ETHEL SPRINGS DAM

NDI No. PA 01121

PHASE I INSPECTION REPORT NATIONAL DAM INSPECTION PROGRAM

Ethel Springs Dam, Westmoreland County, Pennsylvania
NDI No. PA 01121, PennDER No. 65-13
Unnamed Tributary of McGee Run
Inspected 23 June 1980

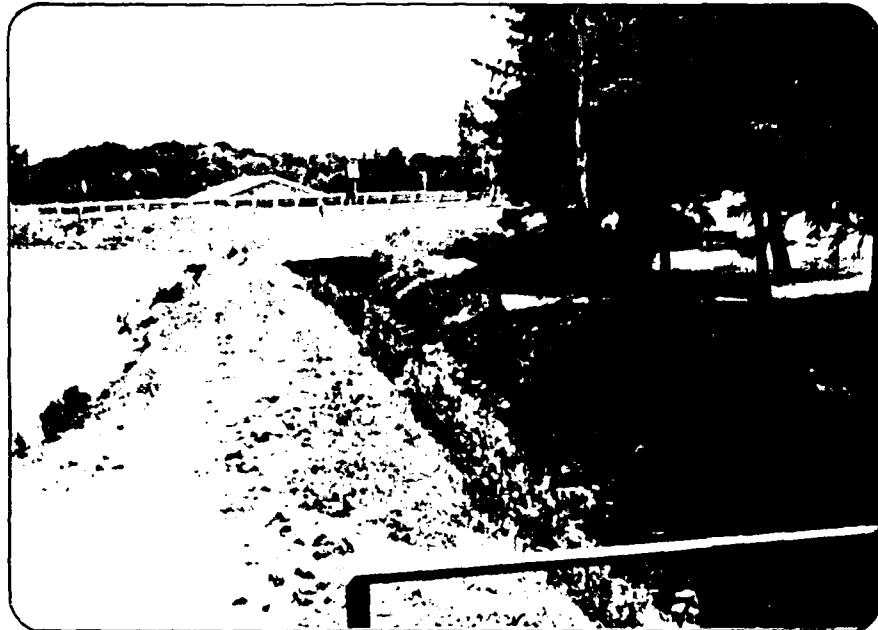
PHOTO 1. View Looking Downstream towards Dam along Crest of Dike

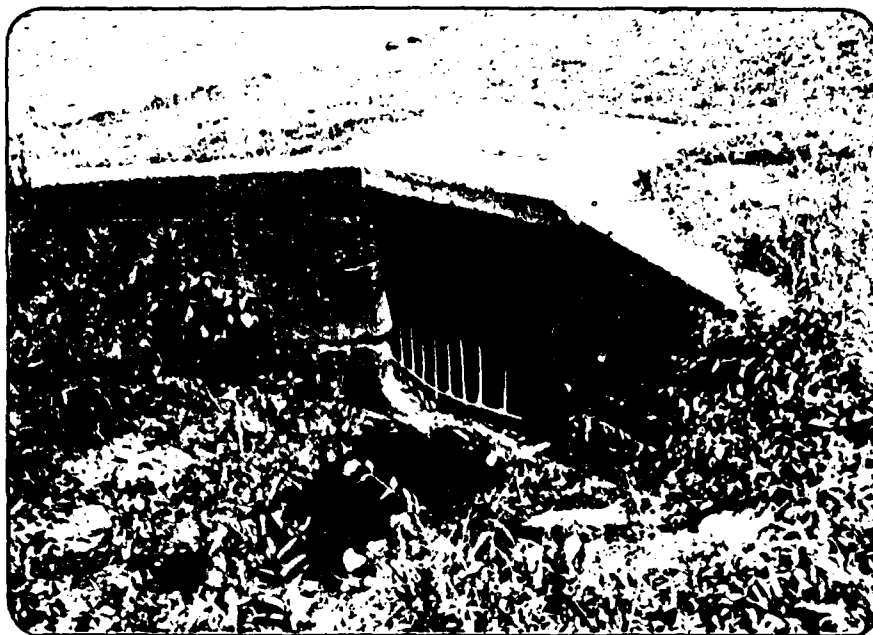
PHOTO 3. View of Outlet for Canal

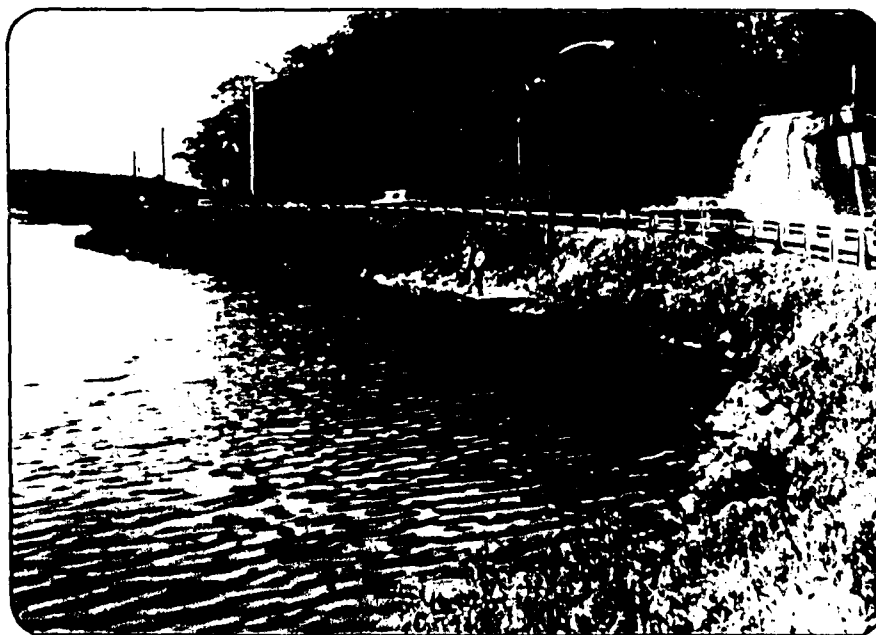
PHOTO 4. View of Reservoir Outlet at Left Abutment

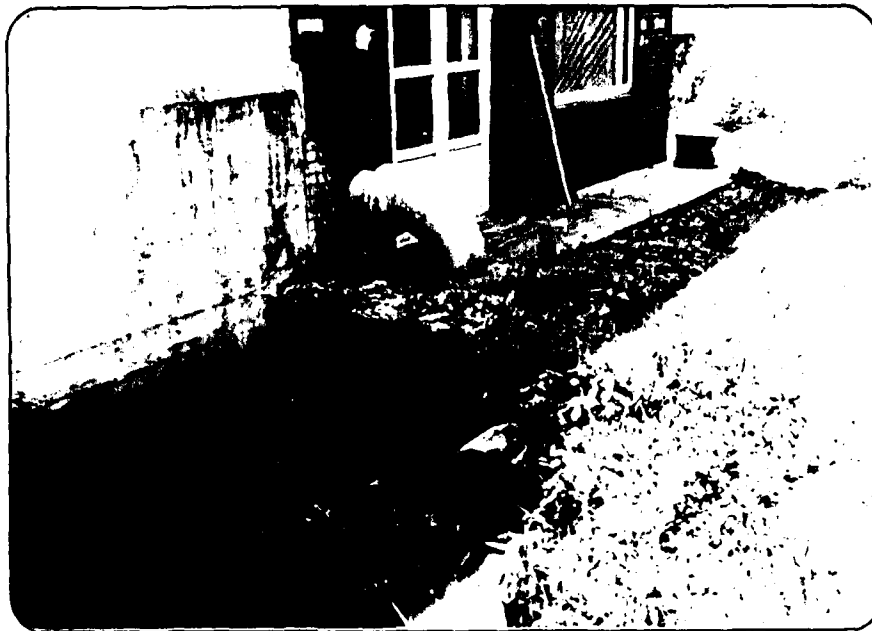
PHOTO 5. View of Reservoir and Canal Outlets

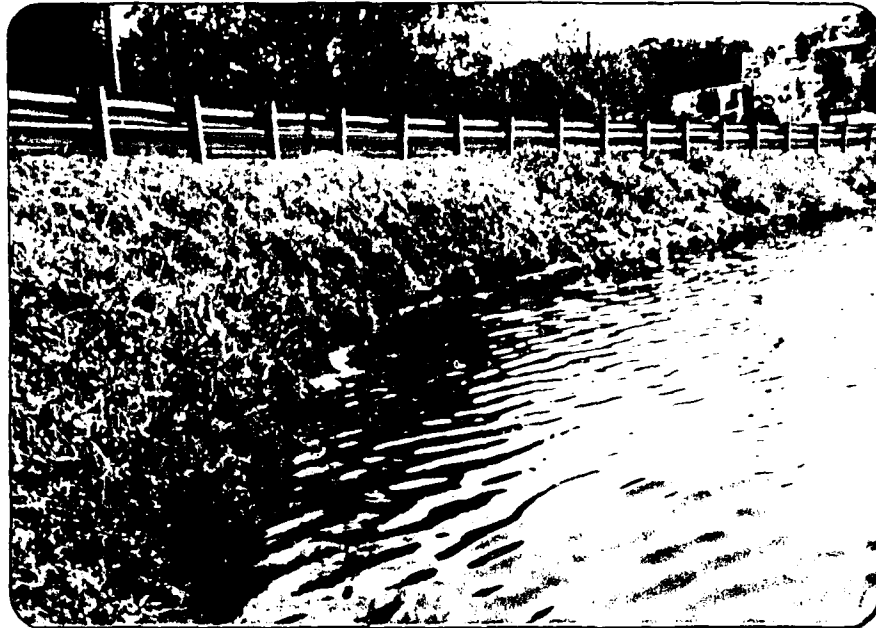
- 2) The riprap on the upstream face has not adequately protected the embankment from erosion and wave action.
 - 3) It appears that some localized movement of the upstream slope may have occurred at the location of a bowed section of guardrail (field Station 1+60) on the upstream edge of the crest. The owner reported that the guardrail had been hit by vehicles two times in this general area with one section requiring replacement. However, due to the possibility of movement of the slope and the very steep embankment above the water level (1.25H:1V at Station 2+00), it is recommended that a detailed investigation of the embankment slopes be performed.

- a. Visual Observations - The erosion and scour on the upstream face of the embankment has made the upper portion (the portion above normal pool level) locally very steep. The presence of a bowed section of guardrail may be an indication of localized movement of the slope. It is recommended that the upstream face be properly repaired and adequate slope protection be installed. A detailed investigation of the embankment slope stability is required to be performed on the embankment slopes before this work is performed.

PHOTO 7. View of Erosion along Upstream Face of Embankment

- 1) Immediate initiation of an engineering study to further evaluate the spillway capacity and develop recommendations for remedial measures to reduce the overtopping potential of the dam. As a part of the analysis, detailed "as built" information concerning the conduits should be obtained.
- 2) Initiate an engineering study to provide a quantitative assessment of the dam and dike stability and develop recommendations for remedial action as necessary.
- 3) As a part of the aforementioned studies, the "as built" condition of the dam should be determined and recorded on engineering drawings for future reference.
- 4) Repair the eroded and scoured areas on the upstream face of the embankment and install proper slope protection.
